EXHIBIT 16

— MILLER HYDRO GROUP —

Re: Miller Hydro Group
Worumbo, 3428
Crib Maintenance

FILE NO. LESDAM	PLAN OF DAM BASELINE AND MOVEMENT CHECK		
FILE NO. PLAN NO. 02	MILLER HYDRO		
	LISBON FALLS, MAINE		
	PROJECT LOCATION		
	CANAL STREET		
TOWN	COUNTY	STATE	
LISBON FALLS	ANDROSCOGGIN	MAINE

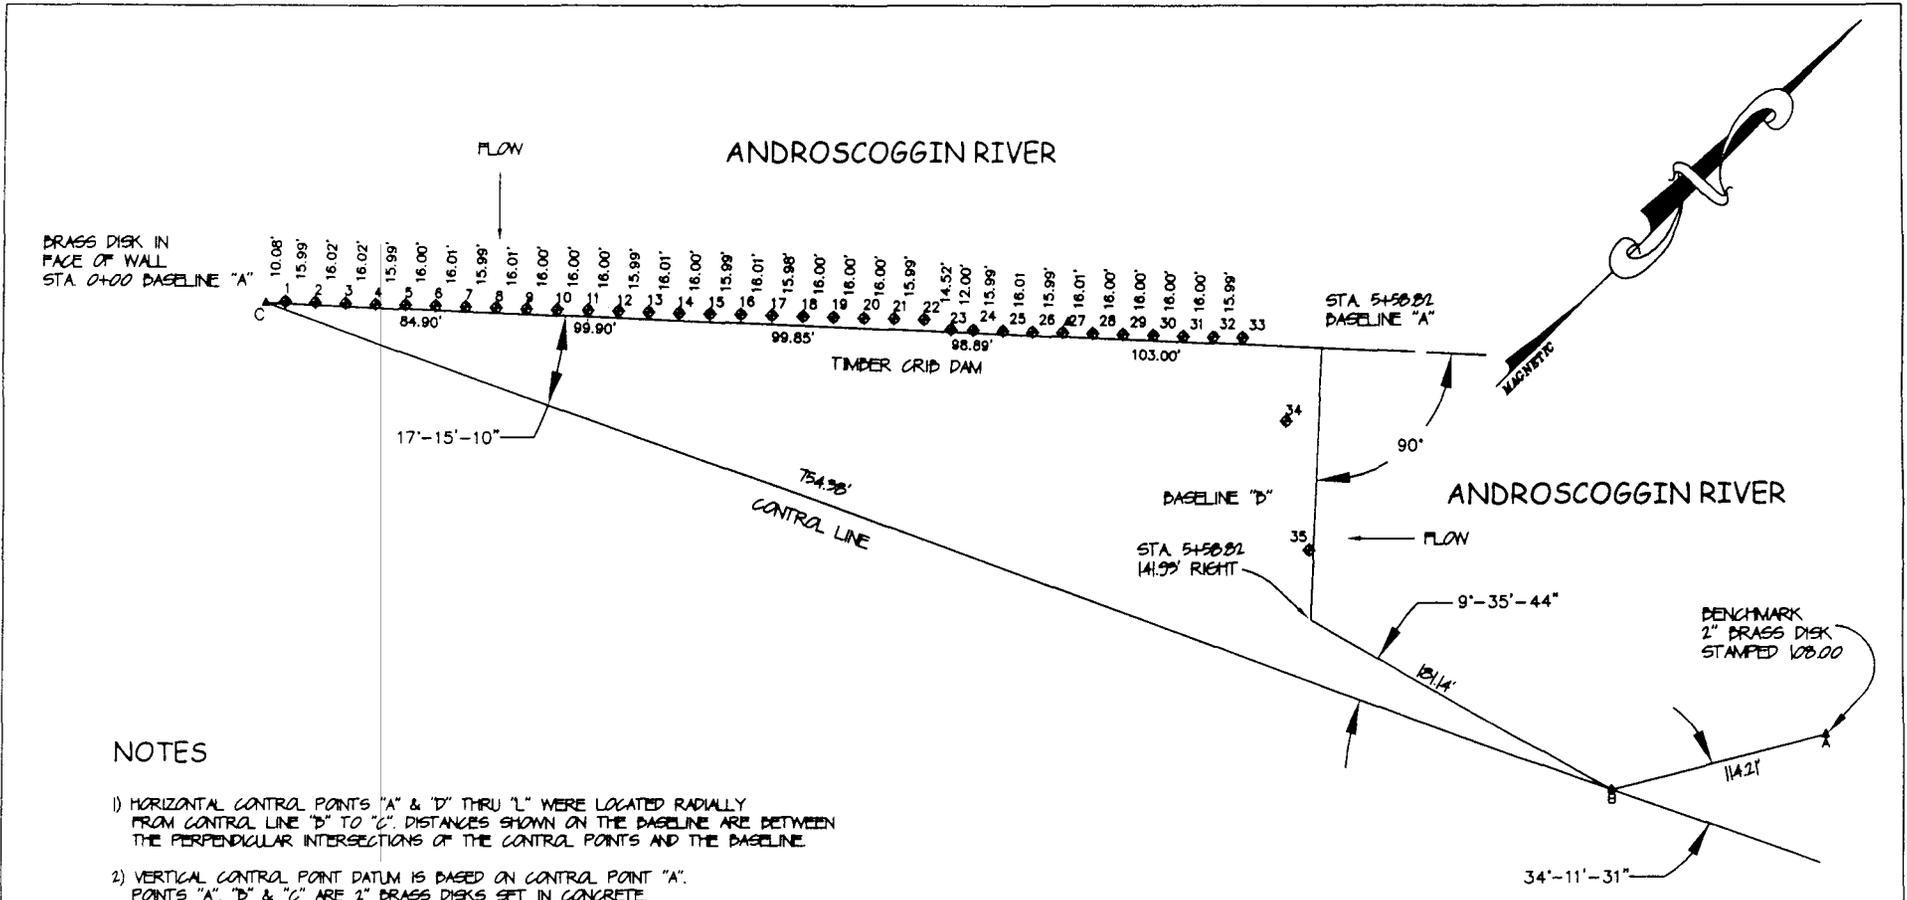
The survey confirms that the dam has settled approximately one inch (0.08 ft) below the elevation surveyed in 2005, but it has not moved laterally. Unlike the 2005, survey which shows uniform settlement below the elevation at which the concrete cap was poured in 1999, over this part of the dam, the current results show a point of maximum compression (point 17 on the attached survey) with progressively less compression in either direction from this point. Survey points 23 thru 33 are on the concrete section of the dam and show no movement from 1999 to 2005 to 2009 and confirm the accuracy of the survey. In the current survey, point 17 is approximately one inch (0.08 ft) below the elevation observed in 2005, and approximately 3 inches below the 1999 elevation.

The compression at point 17 is consistent with the loss of some of the timbers on the downstream face (shown in the attached photos) along with some of the stone fill that these logs had retained. There is no apparent cracking or obvious distress to the concrete cap other than the deformation noted above. Thus, it appears that the cap is acting as a very long beam that is now being allowed to flex downward as the result of the loss of support described above. This is consistent with the high quality of the concrete work and
