## EXECUTIVE SUMMARY

This executive summary and attachments provide a brief overview of the historic structures on Swan Island, and give general guidelines for prioritized repairs. Please refer to the attached Schedule of Repairs (Appendix A), and Individual Building Condition Checklists (Appendix B). For your convenience, we have provided a digital copy of this material, including copies of all photographs taken during the May 18, 2011 site visit.

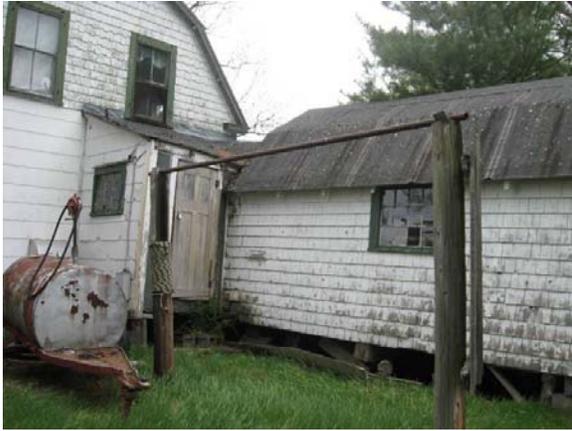
- (A) Exterior View of Rear Ell at Priest Blen, showing electrical entrance
- (R) Rotted Entrance at unsafe Priest Blen ell; with many protruding, rusted nailheads

Of immediate concern is the Priest Blen property and more specifically the Priest Blen House. The Priest Blen house is currently occupied by IF&W staff during the summer months and requires immediate attention in order to ensure the safety of the occupants. We recommend that you remove the ell and secure the attached shed structures immediately adjacent to the Priest Blen House. The structure of the ell has failed beyond repair. Prior to demolition we recommend that you obtain additional detailed documentation if the buildings should be reconstructed in the future. The remaining portion of the House should be stabilized and weatherproofed at the area of demolition. It is also critical to relocate the electrical service into the Priest Blen House, since the ell is in such poor condition. Employee and public safety are compelling reasons to make these immediate repairs.

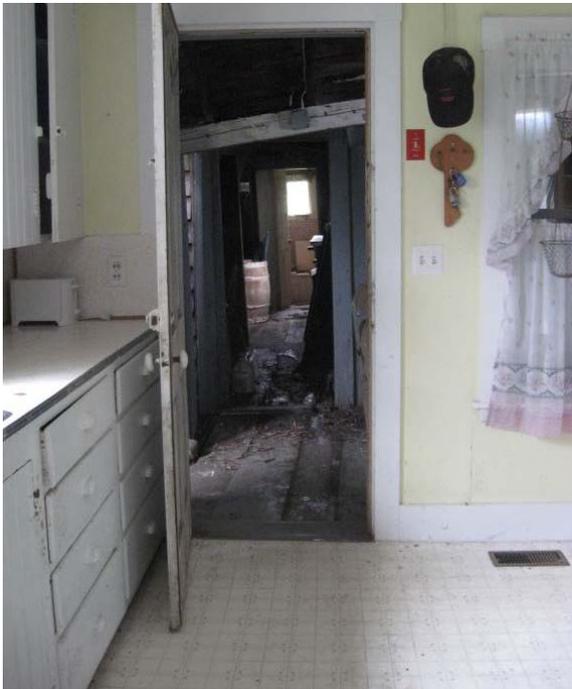
- Unsafe Ell at Back of Priest Blen House, which is occupied by IF&W Staff
- (L) View from Kitchen; Electrical Panel should be relocated into Main House immediately
  - (R) Rotted floor in ell behind Priest Blen Kitchen

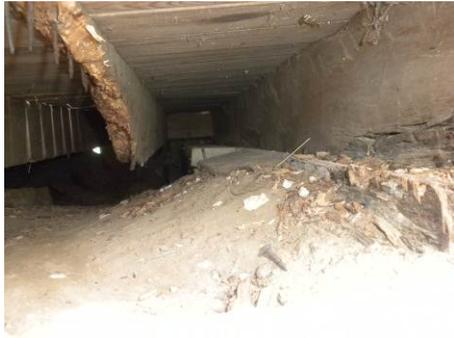
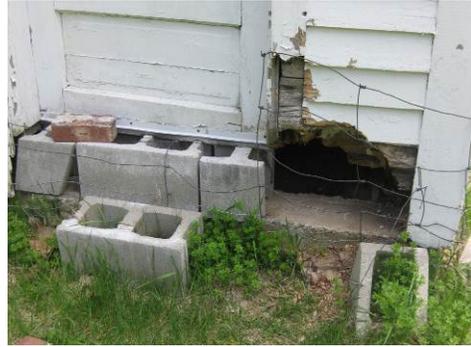
Structural Damage at Porcupine Entry into Gardiner-Dumaesque House

For all of the structures on the island, we have several suggestions for immediate action regarding structural stability concerns, occupant safety and maintenance. First of all, steps should be taken to fully secure all buildings. This includes sealing the buildings from animal entry. Porcupines, specifically, are responsible for surprisingly significant structural damage in many of the buildings including the Gardiner Dumaesque House, the Robinson Powell House and the Lily Wade House. We recommend further discussion with IF&W biologist Kendall Marden to consider porcupine eradication options or solutions that match with the philosophy of the IF&W at this wildlife preserve.

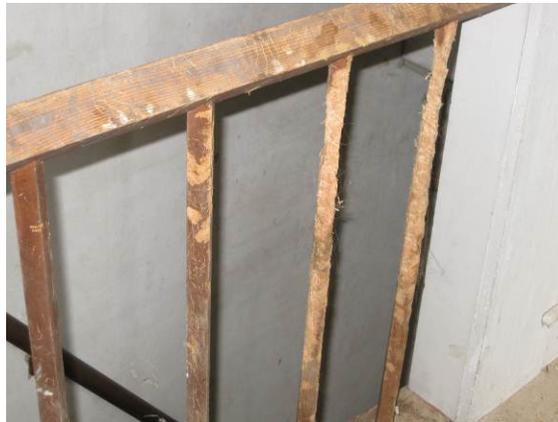
Porcupine Damage on Gardiner-Dumaesque Second-Floor Railing

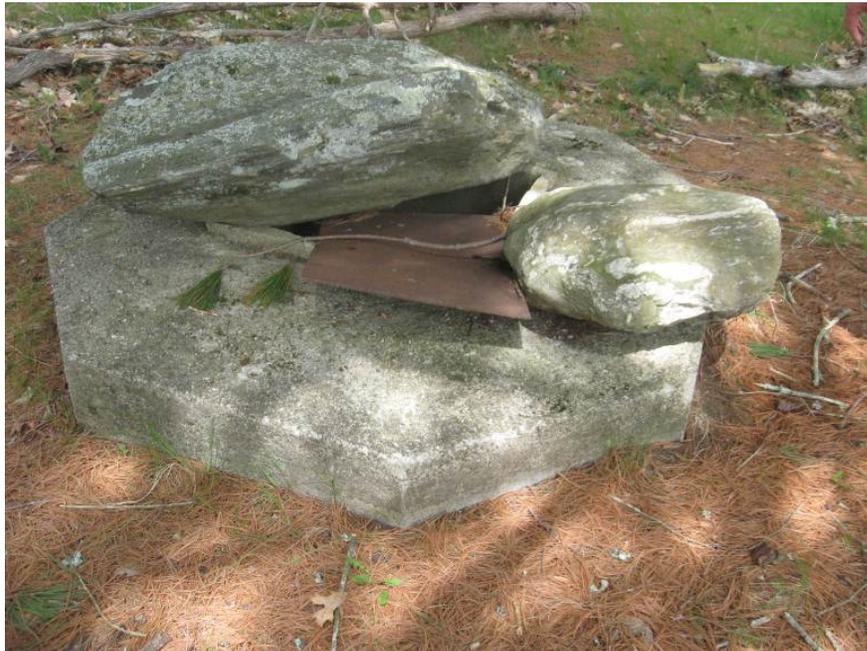
A final item of specific concern, though not part of the inspection, is the condition of the well covering near the Picnic Shelter and Boat House. Relatively small stones and metal plates cover part of the opening, and they could be moved aside, allowing an unsuspecting person or larger animal to fall into the well.

Haphazardly-placed stones and steel plate covering well near picnic shelter
