EXECUTIVE SUMMARY

This executive summary and attachments provide a brief overview of the historic structures on Swan Island, and give general guidelines for prioritized repairs. Please refer to the attached Schedule of Repairs (Appendix A), and Individual Building Condition Checklists (Appendix B). For your convenience, we have provided a digital copy of this material, including copies of all photographs taken during the May 18, 2011 site visit.

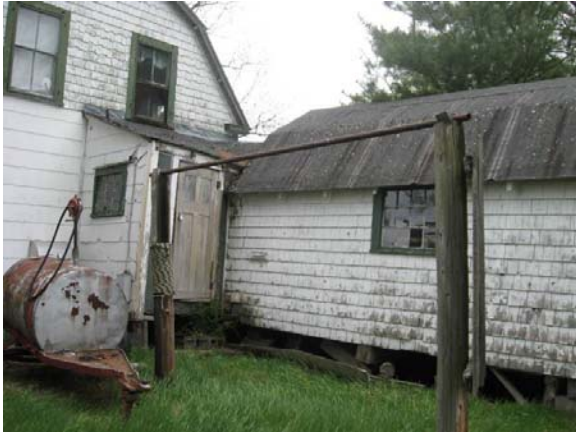
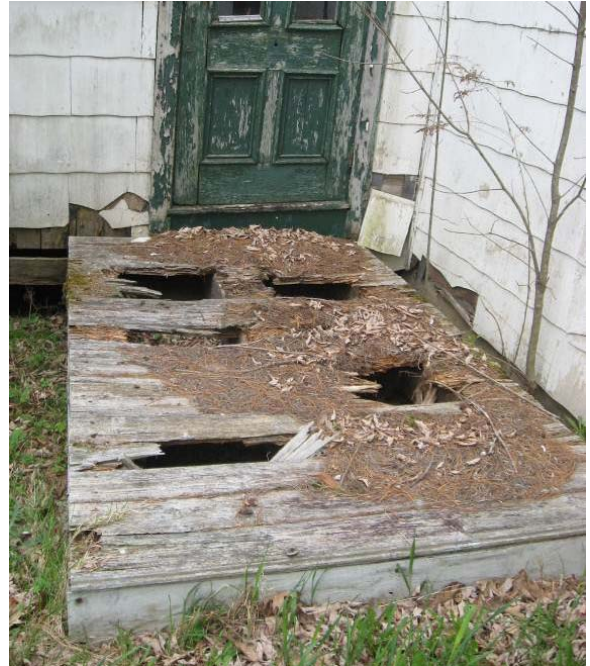
- (A) Exterior View of Rear Ell at Priest Blen, showing electrical entrance
- (R) Rotted Entrance at unsafe Priest Blen ell; with many protruding, rusted nailheads

Of immediate concern is the Priest Blen property and more specifically the Priest Blen House. The Priest Blen house is currently occupied by IF&W staff during the summer months and requires immediate attention in order to ensure the safety of the occupants. We recommend that you remove the ell and secure the attached shed structures immediately adjacent to the Priest Blen House. The structure of the ell has failed beyond repair. Prior to demolition we recommend that you obtain additional detailed documentation if the buildings should be reconstructed in the future. The remaining portion of the House should be stabilized and weatherproofed at the area of demolition. It is also critical to relocate the electrical service into the Priest Blen House, since the ell is in such poor condition. Employee and public safety are compelling reasons to make these immediate repairs.

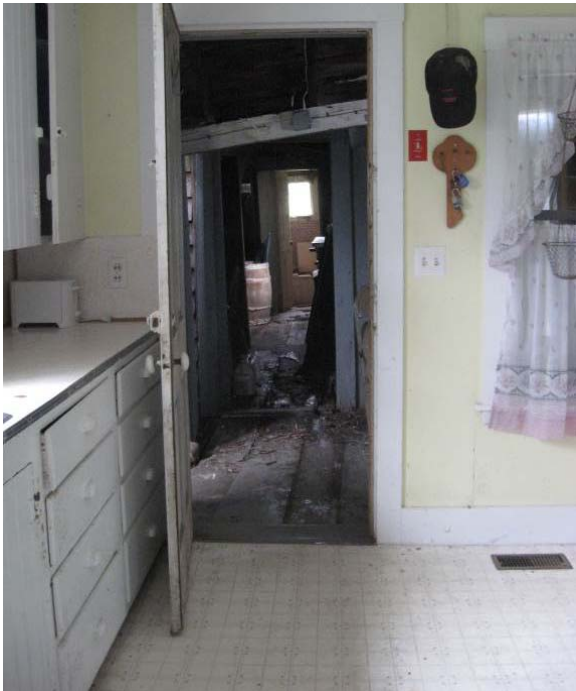
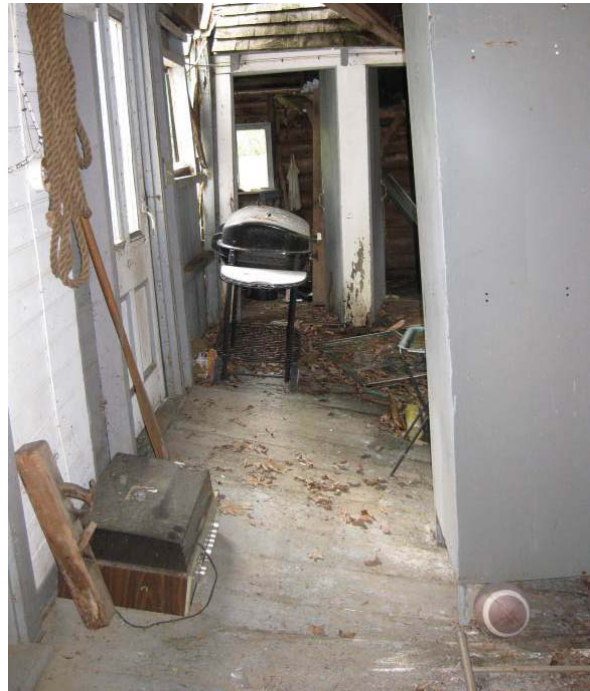
- Unsafe Ell at Back of Priest Blen House, which is occupied by IF&W Staff
- (L) View from Kitchen; Electrical Panel should be relocated into Main House immediately
- (R) Rotted floor in ell behind Priest Blen Kitchen

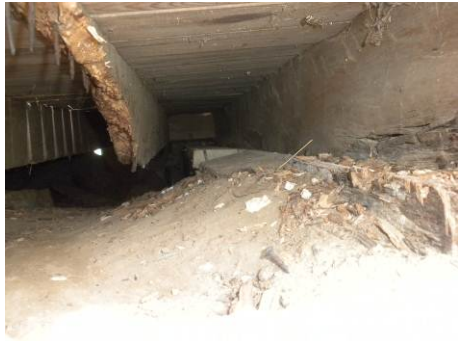
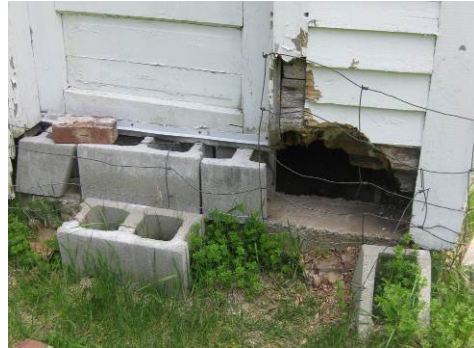
Structural Damage at Porcupine Entry into Gardiner-Dumaesque House

For all of the structures on the island, we have several suggestions for immediate action regarding structural stability concerns, occupant safety and maintenance. First of all, steps should be taken to fully secure all buildings. This includes sealing the buildings from animal entry. Porcupines, specifically, are responsible for surprisingly significant structural damage in many of the buildings including the Gardiner Dumaesque House, the Robinson Powell House and the Lily Wade House. We recommend further discussion with IF&W biologist Kendall Marden to consider porcupine eradication options or solutions that match with the philosophy of the IF&W at this wildlife preserve.

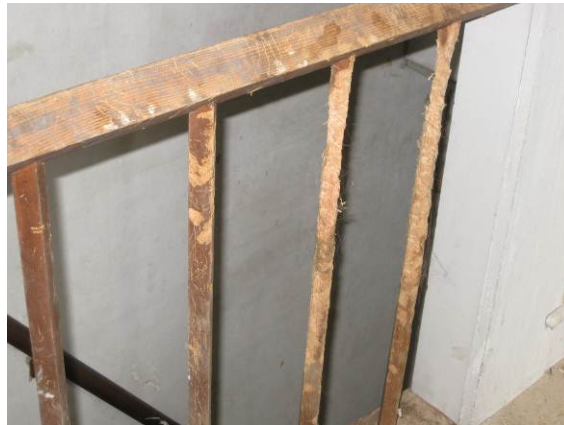
Porcupine Damage on Gardiner-Dumaesque Second-Floor Railing

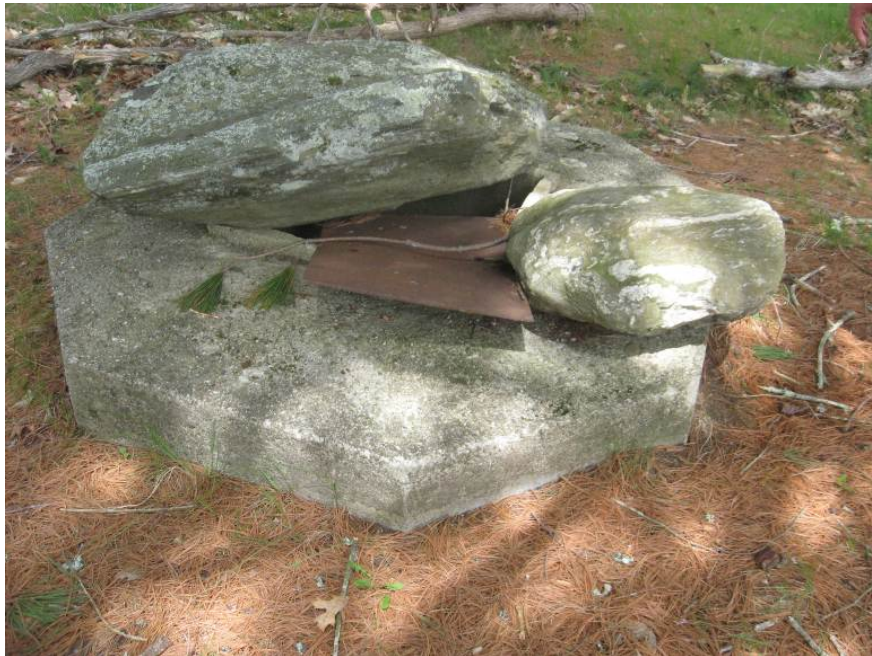
A final item of specific concern, though not part of the inspection, is the condition of the well covering near the Picnic Shelter and Boat House. Relatively small stones and metal plates cover part of the opening, and they could be moved aside, allowing an unsuspecting person or larger animal to fall into the well.

Haphazardly-placed stones and steel plate covering well near picnic shelter
