Brunswick Androscoggin Dam Killing Fish

Who: Friends of Merrymeeting Bay
What: **Brookfield Energy's Brunswick Dam Turbines Kill Thousands of Fish**
When: October 15th & 16th
Where: Androscoggin River, Brunswick

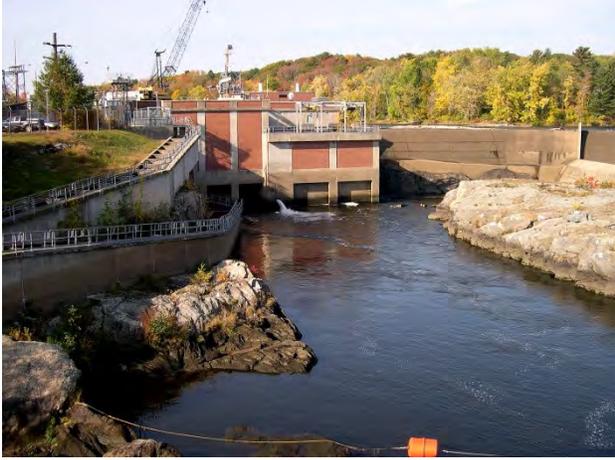
Note first photo of dam shows 18" fish passage "downspout" next to turbine bays. Dam is over 600 feet long and this is only safe passage unless water is spilling over the top.

In normal conditions, the only way for migratory fish to pass downstream at Brunswick is through an 18" pipe with grate over the upstream end and flows of 40 cubic feet per second (cfs). This downstream passage is located immediately adjacent to the Unit 1 turbine with intake extending to the surface and with a throughput of 5,075 cfs. On the other side of the fish passage pipe are Units 2 and 3 with combined 2,672 cfs and entrances about 20' below the surface. Out-migrating fish, whether alewives, salmon, shad or eels follow maximum flows leaving the designated pipe in this instance, with little chance of attraction success and ensuring passage through the turbines.

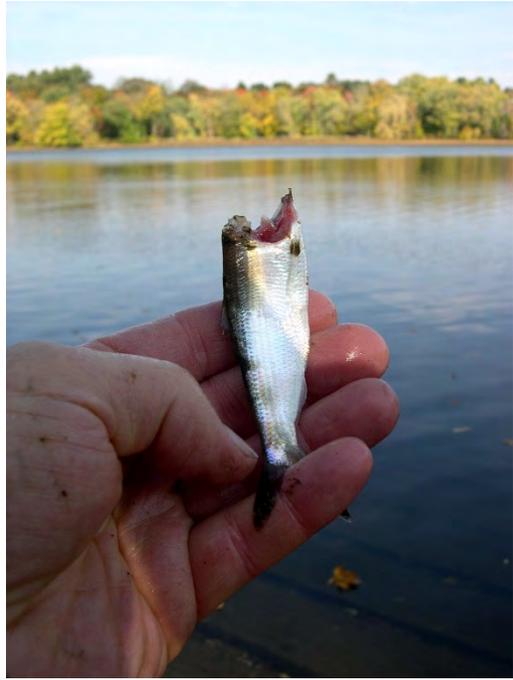
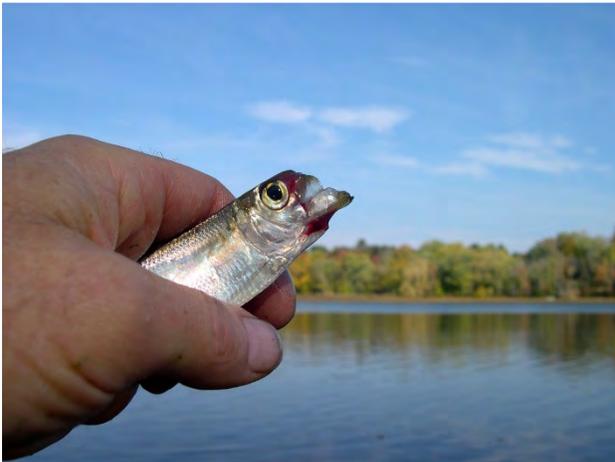
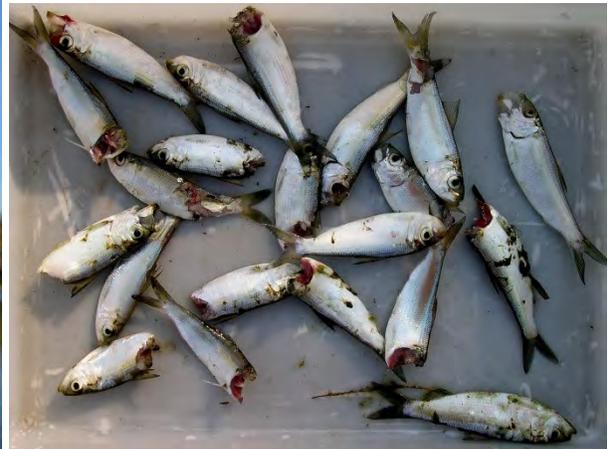
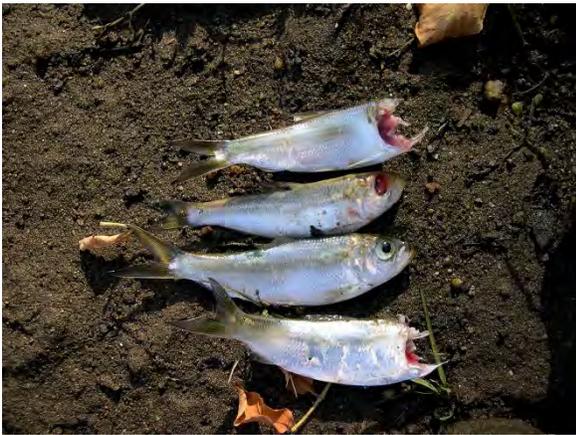
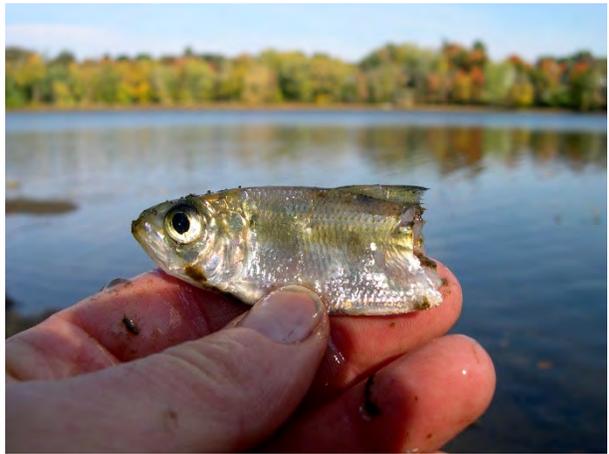
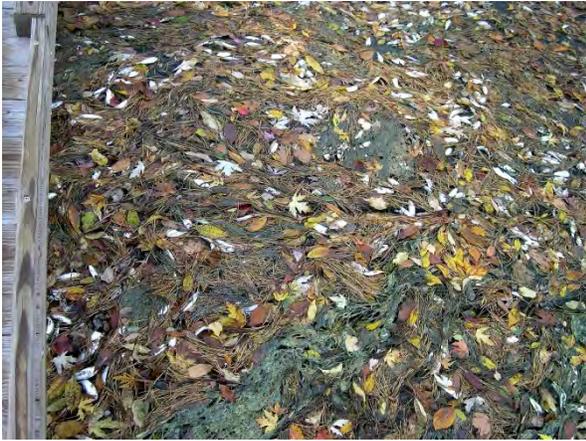
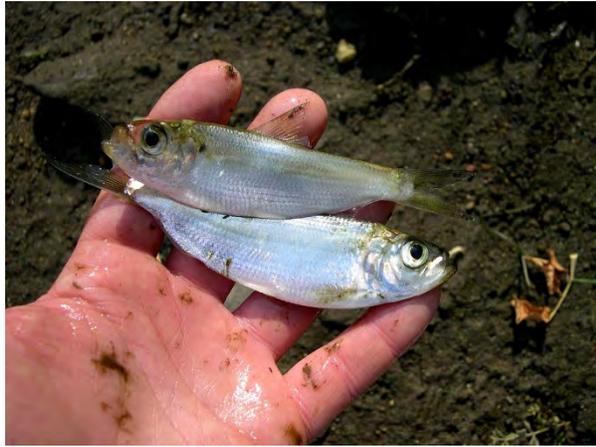
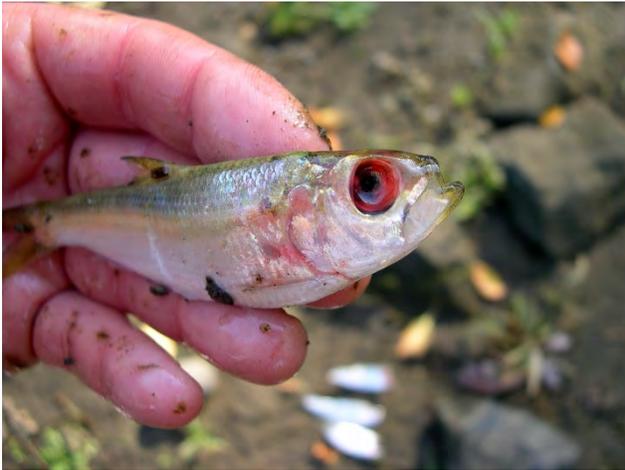
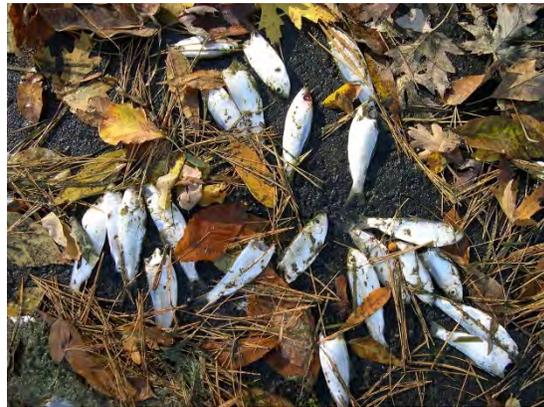
In violation of their Federal Energy Regulatory Commission (FERC) and Maine Water Quality Certificate, the turbines at Brookfield Energy's Brunswick/Topsham dam have just killed thousands of out-migrating young of the year (YOY) alewives and other fish. Locals first noticed the massive kill on Saturday, posting mortality photos from the Brunswick Water Street boat launch on Facebook.

Sunday morning, Friends of Merrymeeting Bay (FOMB) volunteers on their monthly water quality monitoring circuit, noticed the kill at Brunswick and further downstream and reported back to Ed Friedman, the organization's Chair. After documenting 500-800 dead fish just at the boat ramp and others on the rocks below the Green Bridge, Friedman went up and downstream to rule out other sources before calling the Brookfield Emergency Phone Line later that afternoon to report their dam turbines were killing fish. It is not known what immediate action Brookfield took if any.

Turbine mortality occurs through decapitation, direct concussive strikes, and pressure differentials on opposite sides of turbine blades leading to exploded swim bladders and eyeballs. All of these examples were seen in the recent kills. Similar mortality has been encountered on the Union River at the dam in Ellsworth, also owned by Brookfield, a Canadian company and monitored by the Downeast Salmon Federation.
